Sailors and Marines Reducing Mishaps

BRAVGO Zulu

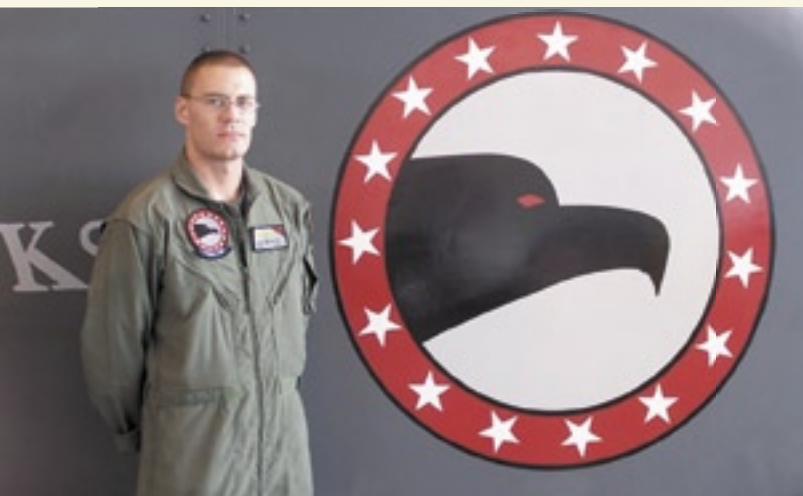
AM3 Michael Monroe
HM-15

Petty Officer Monroe noticed a broken section of the cowl screen on the tail gearbox while preflighting the tail-rotor driveshaft on Hurricane 07. Although the daily and turnaround inspection had revealed no discrepancies in that area, he notified his crew chief. Upon closer inspection, the crew chief found the screen had separated and peeled back from the airframe.

Petty Officer Monroe's actions prevented a possible in-flight cowl failure that could have resulted in severe damage to the tail rotor and loss of the aircraft and crew.

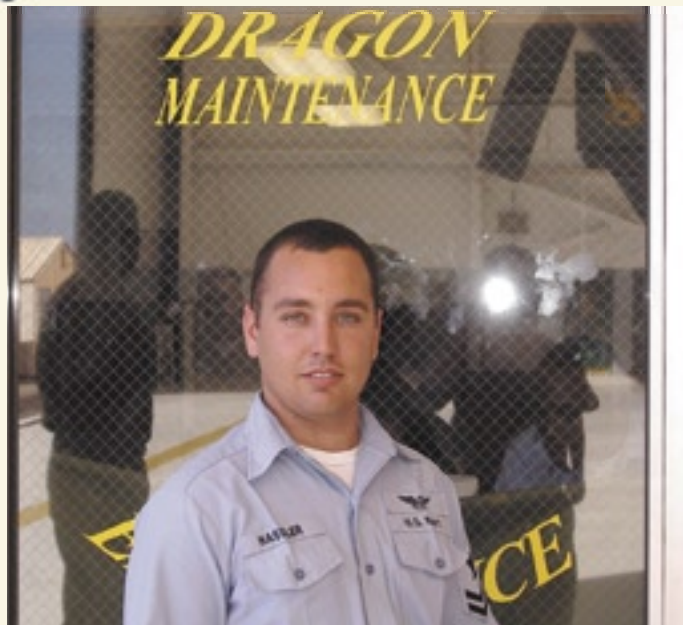
AM2(AW) Kenneth Hassler
HS-11

During a daily and turnaround inspection, Petty Officer Hassler discovered a half-inch-by-7-inch delaminated section on the blue tail-rotor blade. He immediately downed the aircraft until critical repairs could be completed.

Petty Officer Hassler's action prevented the tail rotor from departing the aircraft and resulting in loss of aircrew and aircraft.

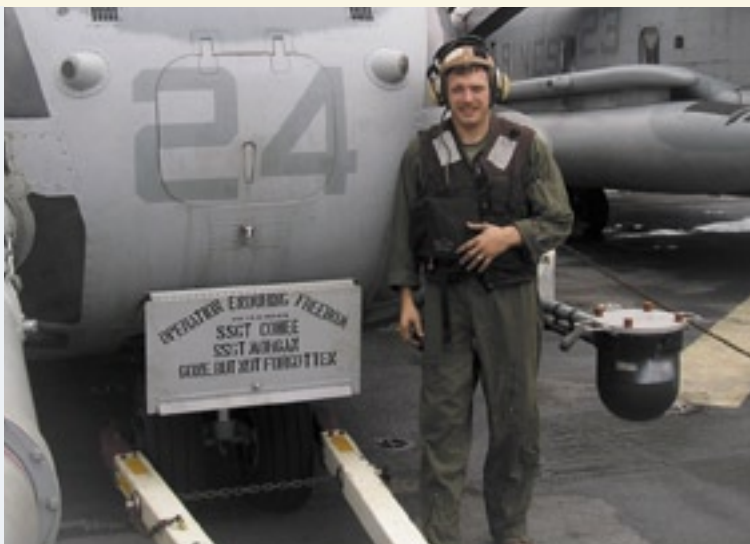
Sgt. Timothy O'Connor
HMM-165

While conducting humanitarian missions in Indonesia during Operation Unified Assistance, Sgt. O'Connor (a CH-53E crew chief) discovered a worn pitch-control rod and bearing. He checked the integrity of the rod on a preflight inspection of the rotor-head assembly and noticed an unusual amount of play between the inner bearing and outer race. The Teflon that surrounds the bearing had worn down, allowing the bearing and the race to make metal-to-metal contact.

If Sgt. Connor had not discovered this condition, it would have caused the bearing to break loose and would have allowed the rod end to strike the sleeve and spindle, causing a total loss of control of the main rotor blade and supporting assembly.

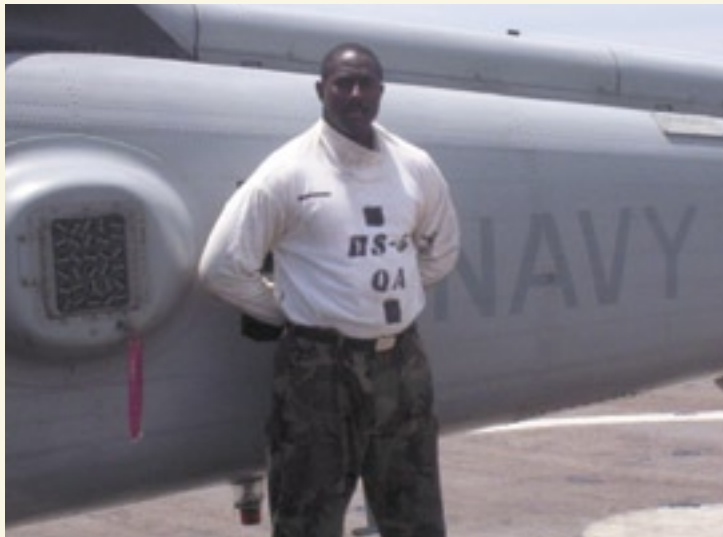
AM1 Flennoy Bellinger
HS-5

While preparing to launch aircraft 615 as part of a two-helicopter launch, Petty Officer Bellinger glanced at aircraft 617 departing off the starboard beam of the ship. He noticed that the tail driveshaft cowling didn't look right. He immediately went to the tower and requested radio contact with 617. He told the pilots to have the aircrew visually check the cowling to make sure it was secured.

The aircrew checked and confirmed that it wasn't secure. Petty Officer Bellinger then safely and expeditiously shut down aircraft 615 and directed that it be moved into the hangar to make a ready deck to recover 617.

Petty Officer Bellinger quickly made the necessary repairs and got the aircraft airborne in just 15 minutes.

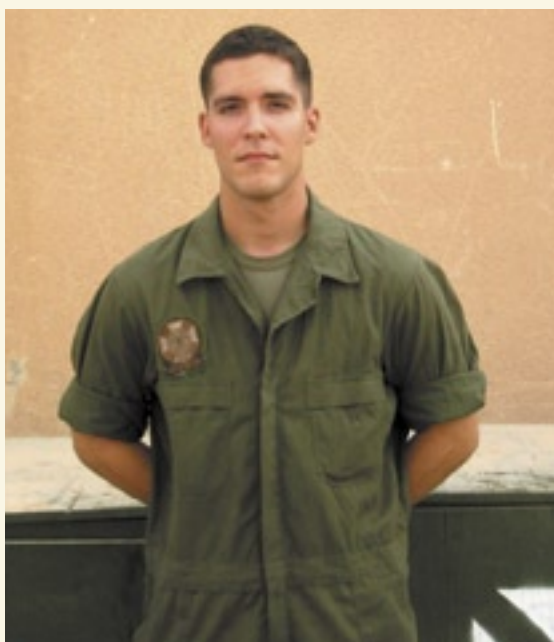
Cpl Adam Gomez
HMLA-169

During a daily and turn-around inspection while deployed to Iraq, Cpl. Gomez found severe scoring of the No. 2 tail-rotor driveshaft in multiple locations of an AH-1W. A broken Dzus fastener receptacle had fallen off the driveshaft access panel and lodged against the driveshaft. The driveshaft was removed for further inspection, and a crack was found from excessive scoring.

Cpl Gomez's thorough inspection potentially saved the aircrew and aircraft from a catastrophic tail-rotor failure.

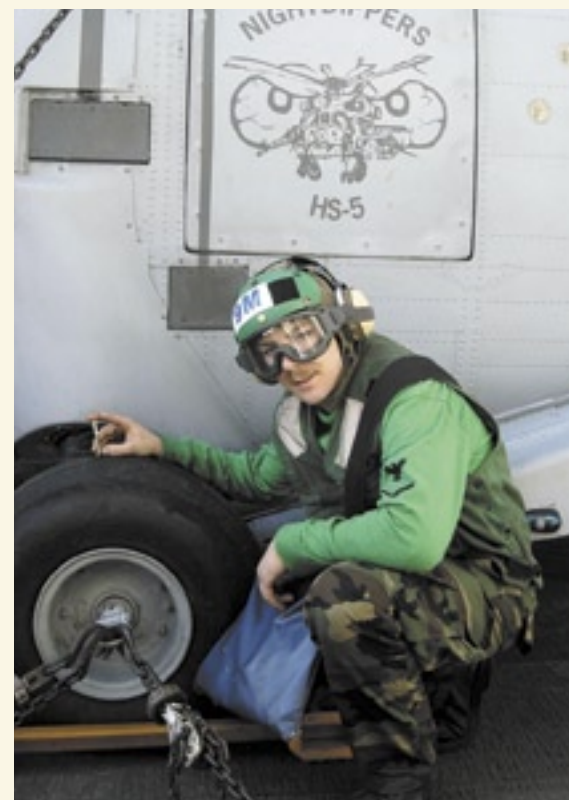
AMS3 Robert Tiller
HS-5

Petty Officer Robert Tiller noticed something a little peculiar while working on a turn-around inspection of a squadron SH-60 helicopter. Upon closer inspection, he discovered and immediately reported a small tear on one of the plastic-coated, power available spindle (PAS) cables on an SH-60 helicopter. Had it not been for his keen attention to detail and quick response, the helo and its crew could have been in grave danger.

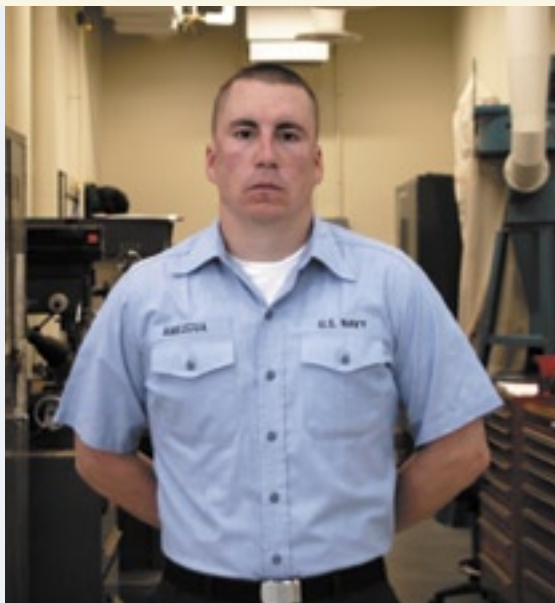
AMAN Ricardo Amezcua
CPRW-5

While helping to move an aircraft at night and in the rain, AMAN Amezcua heard a scraping noise coming from the port main mount on a P-3C. He halted the move and called for an immediate inspection of the main mount. That inspection revealed the wheel assembly was canted slightly and was broken.

Had the move continued, the wheel could have departed the aircraft, causing major damage to the aircraft and possible injury to ground personnel.

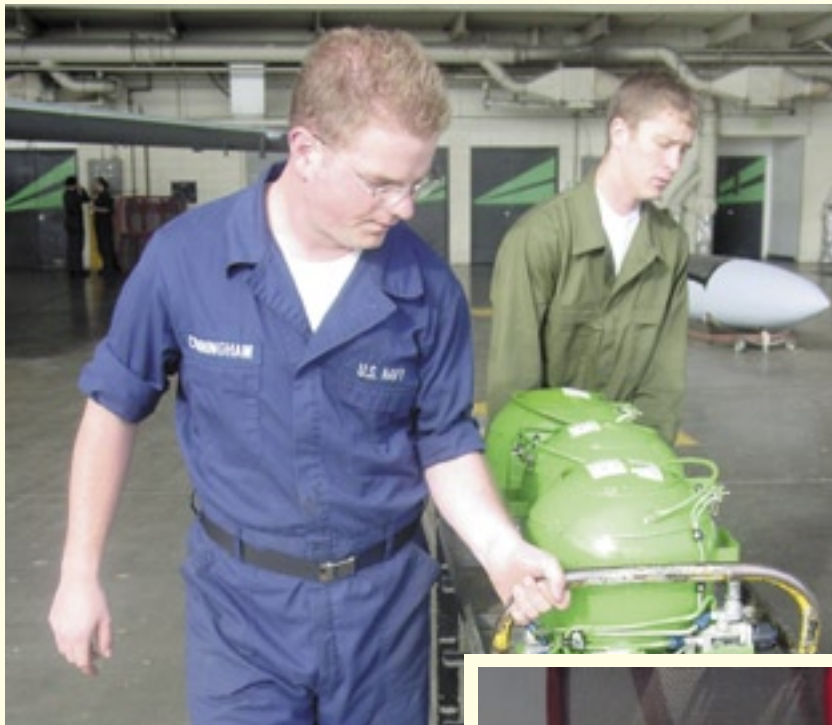
AMEAR Bryan Cunningham
VAQ-135

While on a weekend security watch and during a walk-through of the hangar, AMEAR Cunningham noticed the whistling sound of a leaking liquid oxygen tank in aircraft 500. Upon further investigation, he found two of the aircraft's three liquid oxygen tanks nearly encased in ice.

Had this situation gone unnoticed, the liquid oxygen tank could have exploded.

After consulting with a senior CDI/QAR for advice, he removed the tanks from the aircraft and drained them, a task made arduous by the dangerous and volatile nature of liquid oxygen.

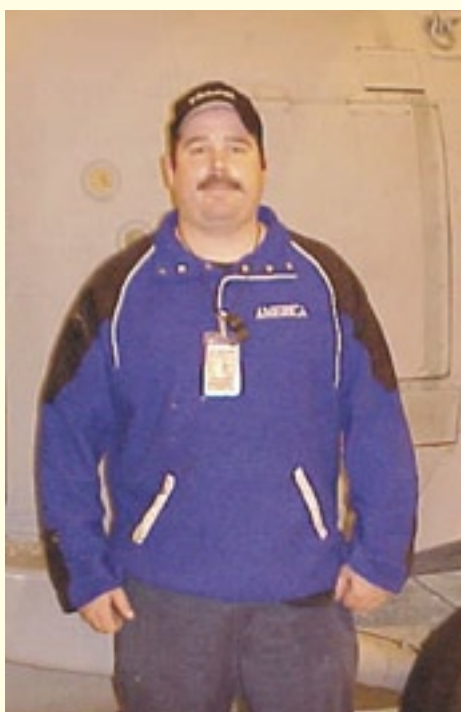
Mark Oakes
NAVAIR Pax River

On an MH-60R's 30-hour inspection, Mark Oakes discovered evidence of a crack that warranted further investigation.

The area was stripped, and the NDI lab inspected it, confirming a 1.8-inch crack at station 327 and just forward of the main beam, preventing the potential loss of aircraft and crew.

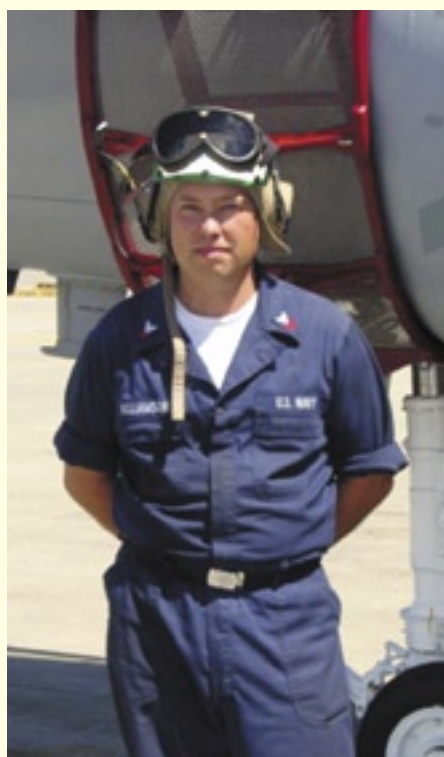
AD1 Mike Williamson
VAQ-142

While troubleshooting compressor stalls on the port engine of aircraft 522, Petty Officer Williamson went the extra mile to determine the cause. Despite a thorough external inspection and ground maintenance turn that wasn't able to duplicate the problem, he decided to do a bore-scope inspection of the engine and found foreign object damage in the sixth stage.

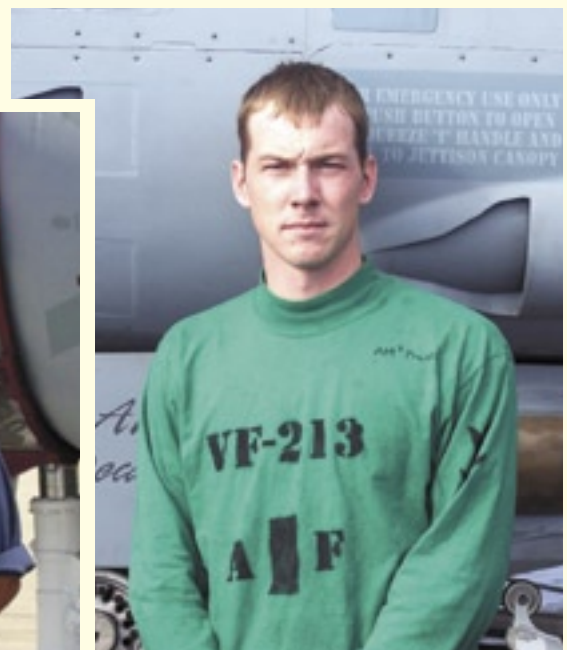
AM3 Craig Powers
VF-213

While doing flight-deck familiarization training from vulture's row onboard USS *Theodore Roosevelt* (CVN-71), Petty Officer Powers noticed a problem while pointing out hazardous areas in and around the landing area. He saw that the cable-support spring for the No. 3 arresting gear had broken after an E-2C Hawkeye did a touch and go landing.

Realizing that the flight-deck crew had not noticed the problem, Petty Officer Powers sprung into action and alerted a member of the crash crew. Flight-deck and primary control were notified in time to wave-off the air wing commander flying Blacklion 205, averting a possible mishap.

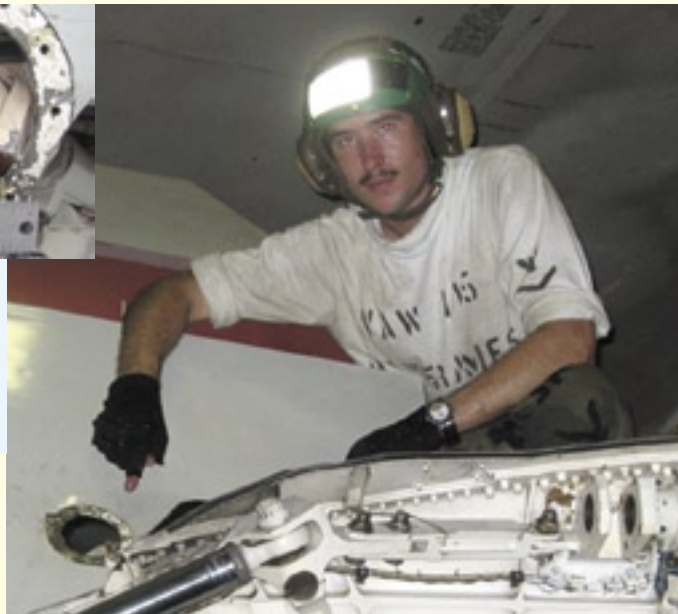
AM3 James Bales
VAW-115

While doing a turn-around inspection on aircraft 603, Petty Officer Bales noticed a torque stripe was broken on one of the starboard wing-fold connecting points. He meticulously inspected the wing's hinge and discovered catastrophic failure on the upper section.

Petty Officer Bales promptly reported his finding to the flight-deck coordinator and also notified maintenance control, averting a potentially catastrophic condition. The repair required the removal and replacement of the entire starboard wing.

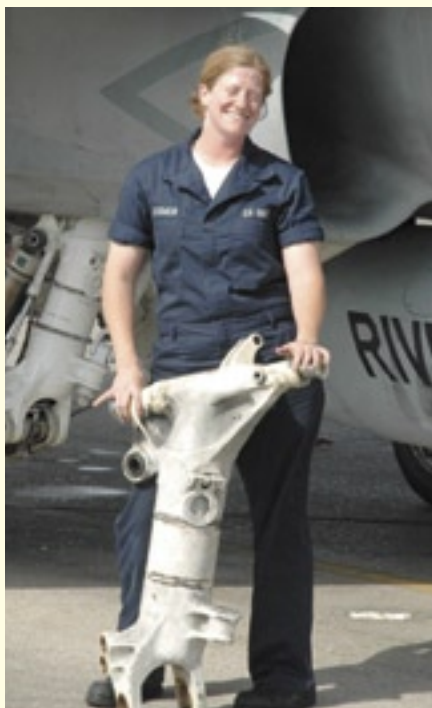
AMAN Amy Harmon
VFA-204

On a daily inspection of River 403, Airman Harmon noticed a very faint defect in the trunnion on the starboard main landing gear. During a closer inspection of the trunnion, she determined the problem likely was a crack. She immediately notified maintenance control that the aircraft was down.

After removing the item for NDI inspection, maintainers found a nine-inch crack in the trunnion. Because of the obscure location of the defect, Airman Harmon found this defect only because of her thorough inspection and extreme attention to detail. This find prevented the catastrophic failure of the landing gear.

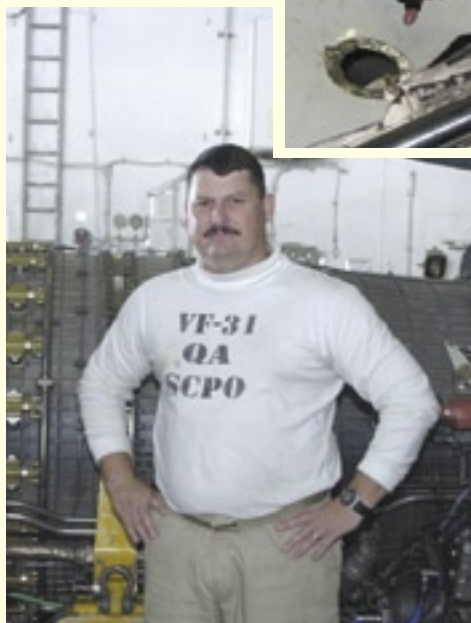
ADCS Gene Casterlin
VF-31

Flight-deck crews reported a grinding noise coming from Felix 100 after it landed on USS *Theodore Roosevelt* (CVN-71). The aircrew hadn't noticed any engine abnormalities throughout the flight, but they did feel a slight aircraft vibration just before landing. The aircraft was downed for further inspection.

External inspection of the aircraft and motor casings, inlet and exhaust sections revealed no discrepancies. Senior Chief Casterlin, the QAS, directed a thorough borescope inspection of both engines' combustion chambers and turbine sections. The inspection revealed that 83 percent of the port engine's high-pressure-turbine blades were cracked and beginning to deteriorate. Senior Chief Casterlin's persistence found the root cause of a potentially deadly discrepancy.

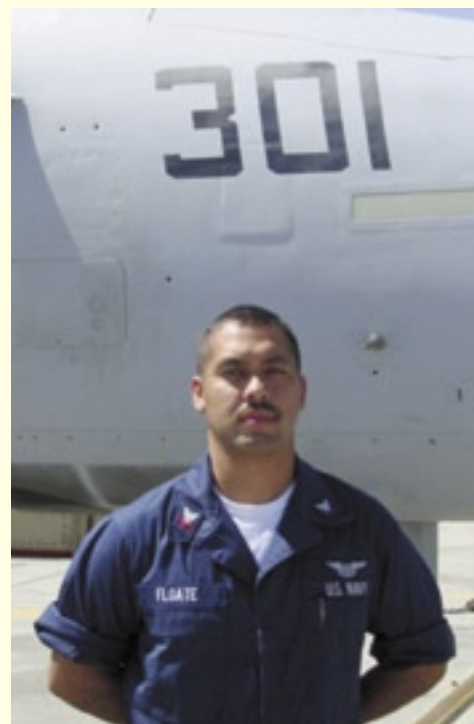
AME2 (AW) Michael Floate
VFA-151

Petty Officer Floate was supervising the installation of FA-18 ejection system components in aircraft 301 when he discovered the aft-support bracket for the canopy rocket motor had been manufactured incorrectly.

Had this bracket been installed it may have resulted in serious injury to aircrew, or even loss of life, if a pilot had to eject. Petty Officer Floate's initiative, attention to detail, and in-depth knowledge of the F/A-18 systems prevented this situation from happening.
